# LOWER CONN RIVER BASIN CLINTON, CONNECTICUT

## INDIAN LAKE DAM CT 00189

PHASE 1 INSPECTION REPORT
NATIONAL DAM INSPECTION PROGRAM

MARCH 1981

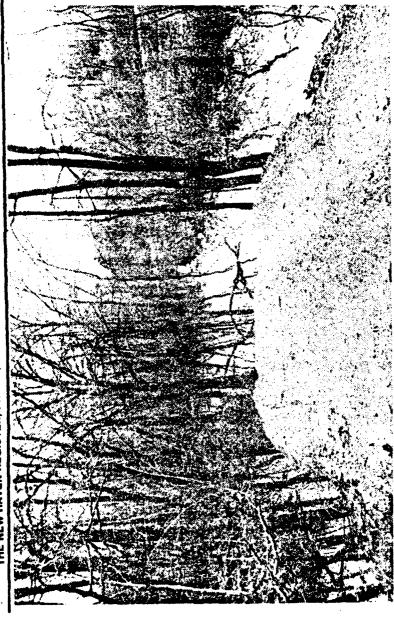
road off Old Mill Road in Clinton. Civil Preparedness Director Gerald Vece said many local roads were Mill Pond Dam reportely was stable Thursday, but that didn't stop water from flooding this nearby dirt having a difficult time recuperating from the relentless rain. (Staff photo by Nancy Combs). BUCK & BUCK

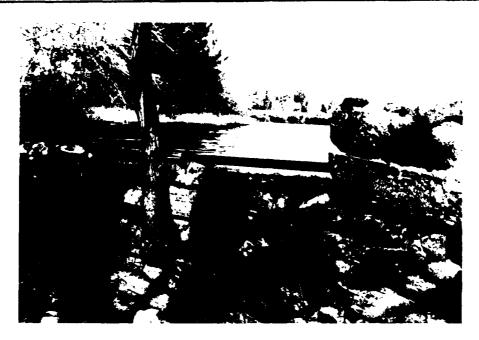
Photo <sup>3</sup> - Close-up of downstream wall at left end of spillway. Note tree growing out of spillway wall and upward displacement of stones. Horizontal direction indicated with level rod.

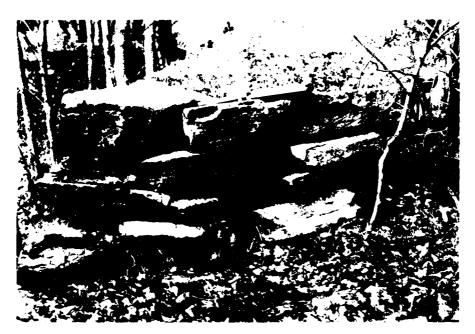
Photo 4 - Right training wall of spillway. Note large voids and tree growing at upstream end. (Extreme right of photo.)

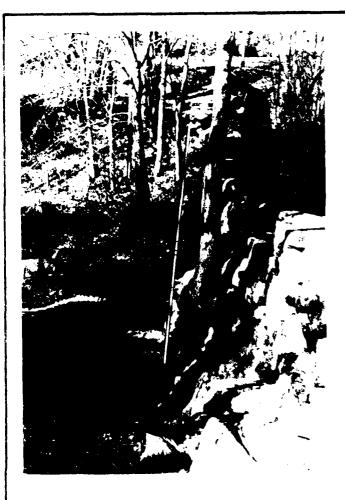
### Photo 5

Downstream side of spillway, showing same tree as on photo 4. Note irregular crest of spillway and siltation on upstream side of spillway.
